## Structure and Microstructure Studies of Epoxy Coating After Natural Exposure Testing

**Summary:** In this work, visual evaluation, Scanning electron microscopy (SEM)/energy dispersive X-ray (EDX) analysis and Fourier transform infrared (FTIR) spectroscopy were used to study the degradation of an epoxy coating system applied on mild steel test panels (10cm x 15cm) exposed at two natural exposure test sites. After surface preparation and application of coating, test panels were subjected to natural exposure at industrial and urban test sites located in Karachi, Pakistan. Visual evaluation showed that the major modes of degradation were totally different at two natural exposure test sites. Scanning electron microscopy (SEM) revealed that the testing caused changes in the surface morphology of the epoxy coating systems with natural exposure testing at urban site showing less surface degradation. Good correlation was observed between the SEM and gloss measurements. Energy dispersive X-ray (EDX) analysis indicated the increase in oxygen content and O/C (oxygen/carbon) ratio for exposed coatings as compared to unexposed coating. Increase in O/C ratio showed that the photodegradation o

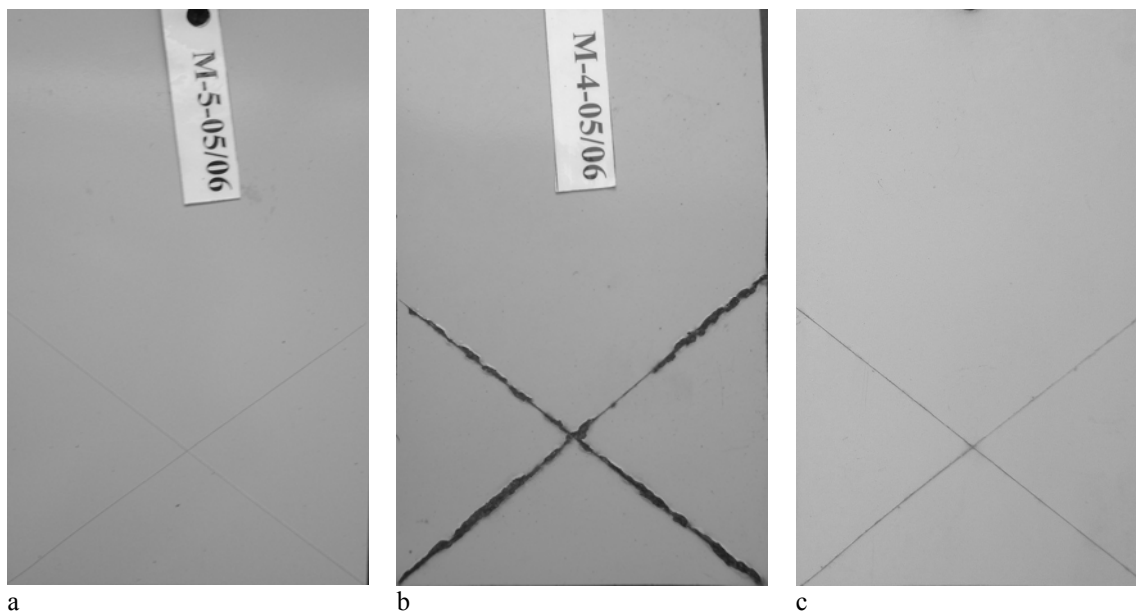
Table-1 presents the results of visual evaluation of the degradation of epoxy coating systems exposed at two different natural exposure test sites. Natural exposure testing at industrial test site indicated the appearance of blisters and rust after 3 months of exposure. With the passage of time increase in degree of blistering and rusting was observed. After 12 months coating system was removed due to severe corrosion and coating delamination from the scribed region. Coating delamination from the scribed region appeared to be caused by the formation of underlying corrosion products.

In contrast, natural exposure testing at urban test site showed no blister formation or rusting even after 6 months of exposure. Further exposure caused the formation of some blisters and rust on the surface of coating. After 18 months exposure was stopped in order to study the degradation by other methods. In both types of testing cracking was not observed. Blisters formed in industrial environment were more in quantity and large in size. Comparison of the results indicated different modes of degradation of epoxy coating systems in industrial and urban environments. Fig. 2 shows the state of the scribed region of unexposed and exposed epoxy coating systems.

Fig. 2: State of scribed region of Epoxy coating systems a) unexposed b) after natural exposure testing at industrial site and c) after natural exposure testing at urban site.

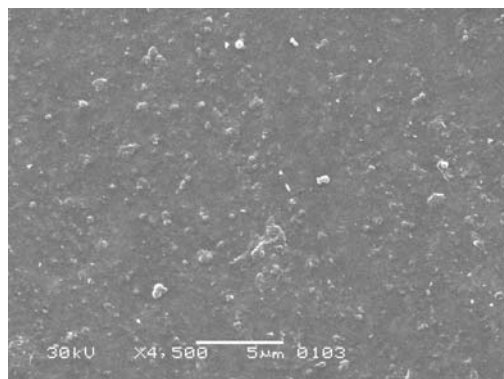
Fig. 3: SEM micrograph showing the surface morphology of unexposed epoxy coating system

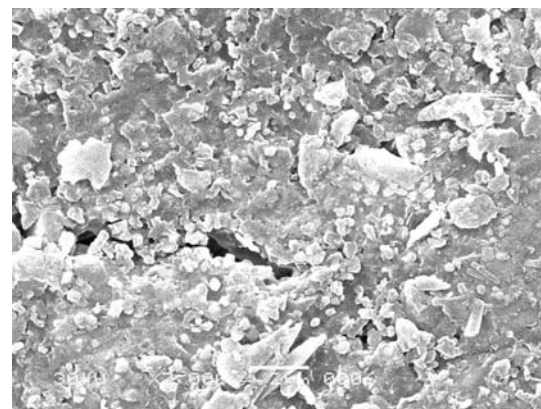
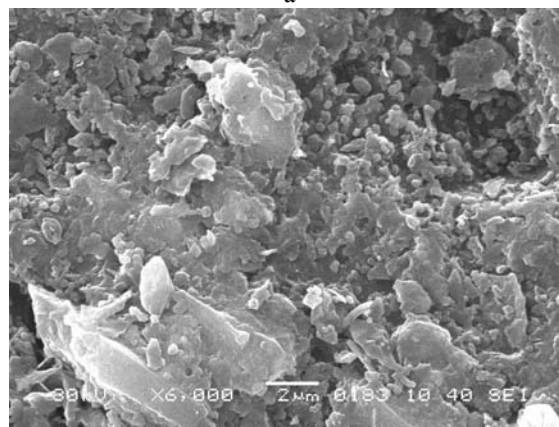
Fig. 4: SEM micrographs showing the surface morphology of the epoxy coating system after natural exposure testing at industrial site

Good correlation was observed between gloss measurement and SEM results. Natural exposure testing at industrial site indicated high degradation of the surface of epoxy coating as compared to testing at urban site (Fig. 4 and 5). This surface roughening explained the decrease in gloss for the epoxy coating system exposed at industrial test site (Table-2). This was consistent with the finding of F.X. Perrin, et al [27]. They related the loss of gloss with the increase of the surface roughening for the coating systems.

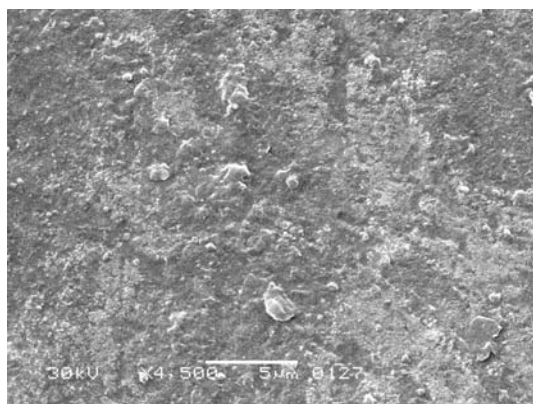
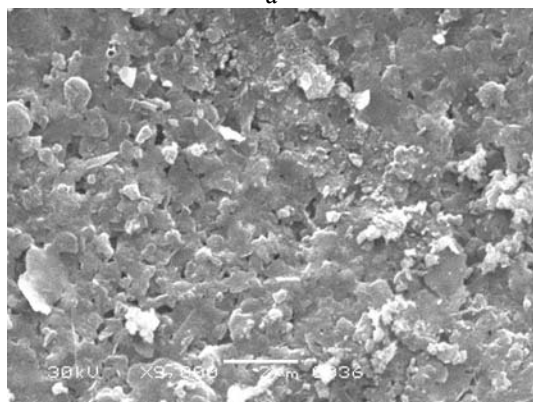
Fig. 5: SEM micrographs showing the surface morphology of the epoxy coating system after natural exposure testing at urban site.

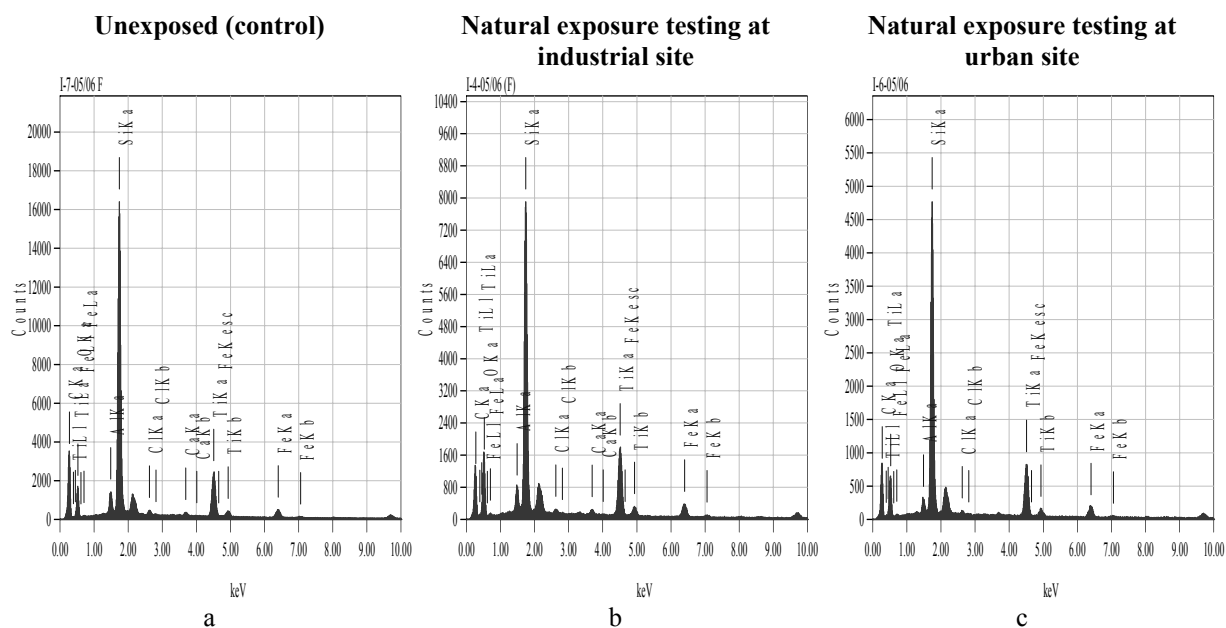
Fig. 6 shows the comparison of the EDX spectra of the unexposed and exposed epoxy coating systems and Table-3 presents the surface composition data of epoxy coating systems as determined by EDX analysis. EDX analysis showed the presence of C, O, Al, Si, Cl, Ca, Ti, and Fe in the unexposed coating. In order to find the correlation between the unexposed and exposed coating systems, Principle of component analysis (PCA is a method of statistics) was applied on the data obtained from EDX analysis, Fig. 7. Graph shows that no correlation was observed for carbon, oxygen, silicon and titanium and the major chemical change occurred in the mass% of C and O.

Fig. 6: Comparison of the EDX spectra of the epoxy coating systems a) unexposed b) after natural exposure testing at industrial site and c) after natural exposure testing at urban site.

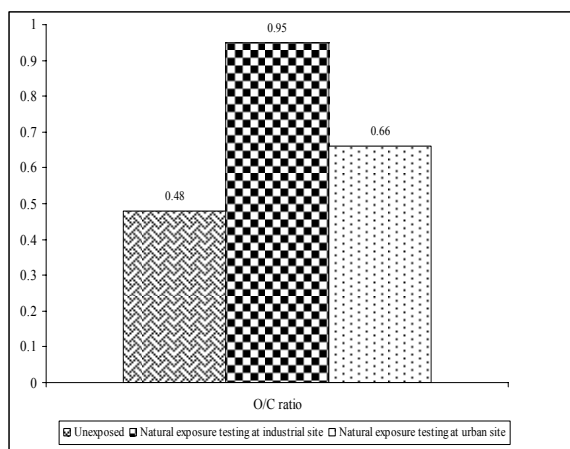
Fig. 8 shows the comparison of O/C (oxygen/carbon) ratio as determined by EDX analysis for unexposed and exposed epoxy coating systems. This indicated the raise in O/C ratio of the exposed coatings as compared to unexposed coating. Particularly, O/C ratio after natural exposure testing at industrial site is higher than that of the O/C ratio obtained after natural exposure testing at urban site. This was due to the high degradation of coating material in industrial environment. X.F. yang, *et al.* [28] suggested that the increase in O/C ratio is due to the reaction of environmental oxygen with the coating which results in oxidation of coating. Several photo-oxidation products form as a result of oxidation of coating [29].

Fig. 8: Comparison of O/C (oxygen/carbon) ratio as determined by EDX analysis for epoxy coating systems.

EDX analysis illustrated high O/C ratio obtained for epoxy coating system exposed at industrial test site which correspond to increase photo-degradation of coating (Fig. 8). Fourier transform infrared spectroscopy also revealed high oxidation of coating's material and formation of oxidation products for the epoxy coating system exposed at industrial test site (Fig. 9b).

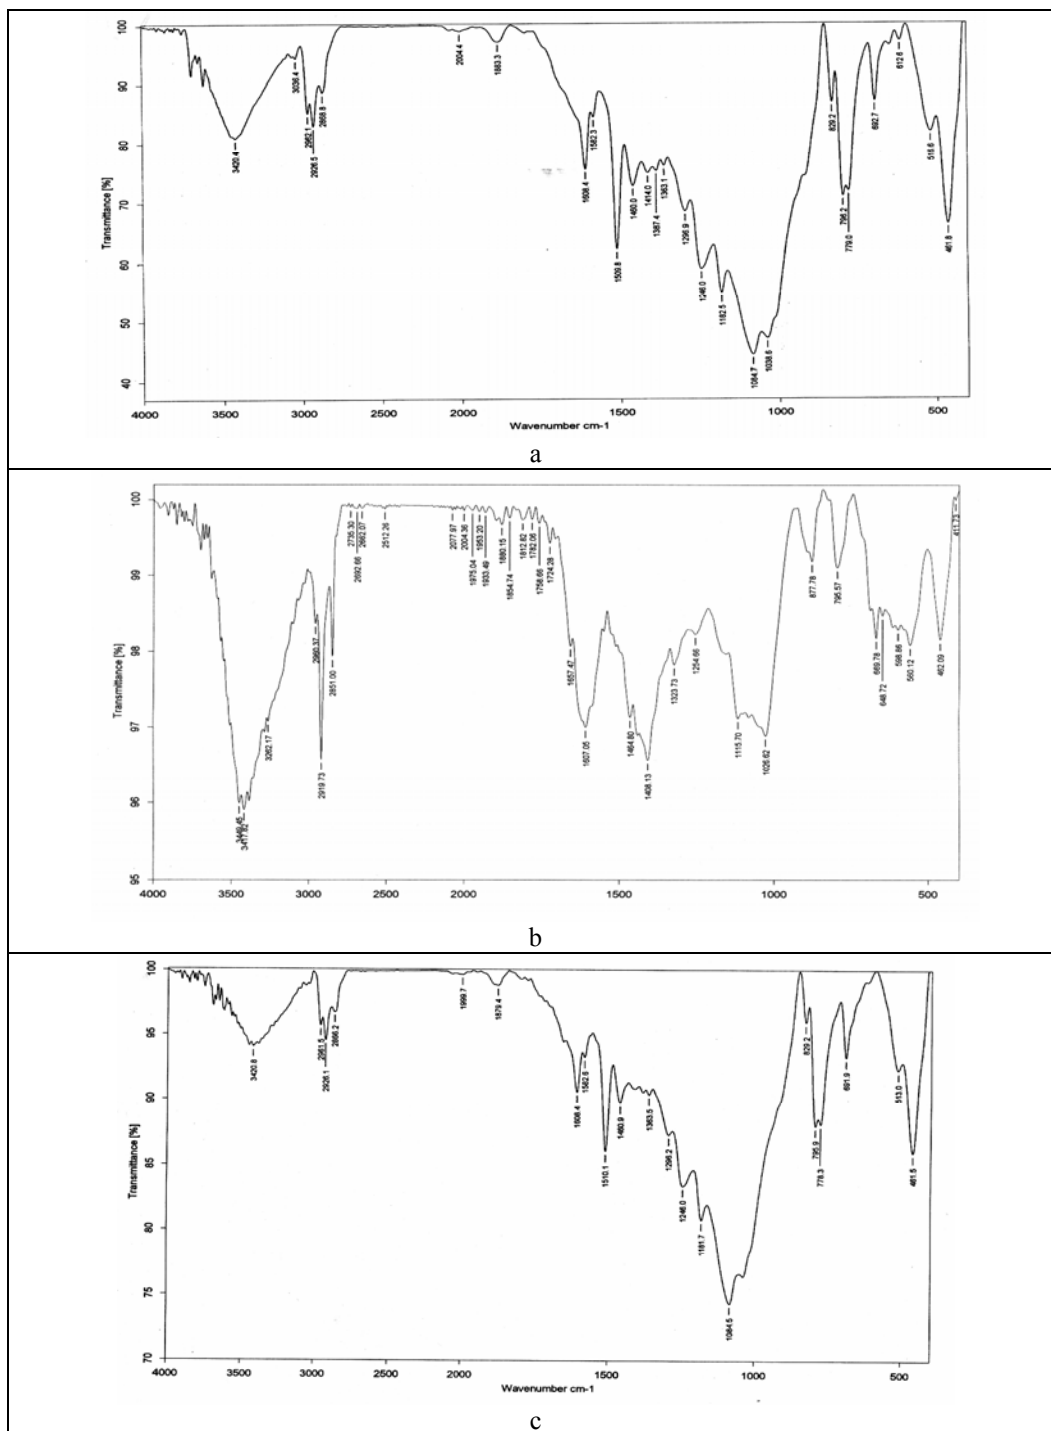
Natural exposure testing at industrial site showed decrease in the peak intensities of C-O stretching vibration of aryl ether near  $1250\text{cm}^{-1}$  and C=C stretching of aromatic nucleus in the region of  $1500\text{--}1600\text{cm}^{-1}$ , (Fig. 9. [b]). It was an indication that chain scission and mass loss in the coating have taken place. The spectrum also showed the formation of new chemical species having peaks in the region of  $1620\text{--}1800\text{cm}^{-1}$ . Due to the formation of oxidation products, two prominent bands at  $1658\text{cm}^{-1}$  and  $1725\text{cm}^{-1}$  were observed, which could be attributed to C=O stretching of ketone and C=O stretching of amide respectively. The carbonyl band at  $1725\text{cm}^{-1}$  has been attributed to the formation of ketone products by Bellinger [14] or to aldehyde formation by Petterson- Jones [13]. In either case the products are formed by the release of water molecules by dehydration of the hydroxyl groups.

Natural exposure testing at urban site revealed changes in the similar regions, however, the changes were less severe as compared to natural exposure testing at industrial site, (Fig. 9. [c]). In this case, less decrease in the peak intensities of the C-O stretching vibration of aryl ether near  $1250\text{cm}^{-1}$  and C=C stretching of aromatic nucleus in the region of  $1500\text{--}1600\text{cm}^{-1}$  were observed. This was an indication of less chemical degradation of the epoxy coating system due to natural exposure testing at urban site.

Fig. 9 Infrared spectra of Epoxy coating systems a) unexposed b) after natural exposure testing at industrial site and c) after natural exposure testing at urban site.
